United States Fire Administration

Technical Report Series

The East Bay Hills Fire Oakland-Berkeley, California

Investigated by: J. Gordon Routley

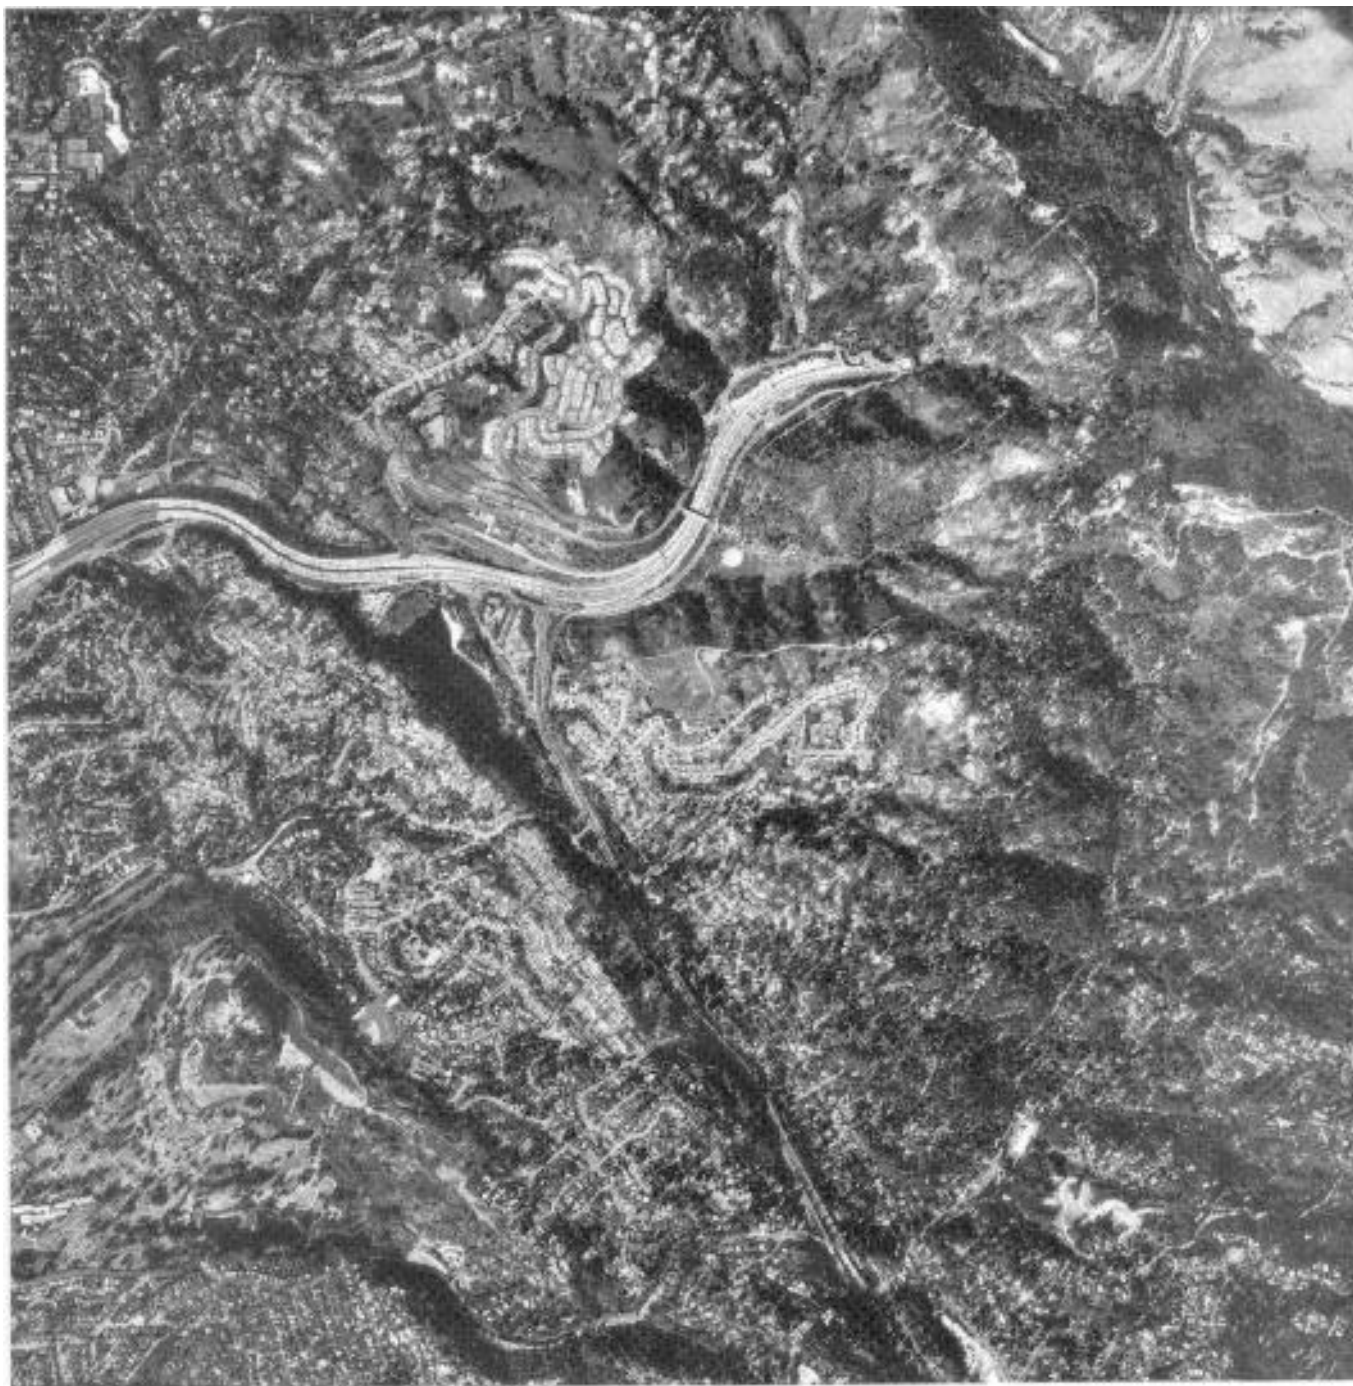
Aerial photograph taken after the fire. Area shown is the same as on page 12.
In total 3,354 structures were destroyed.

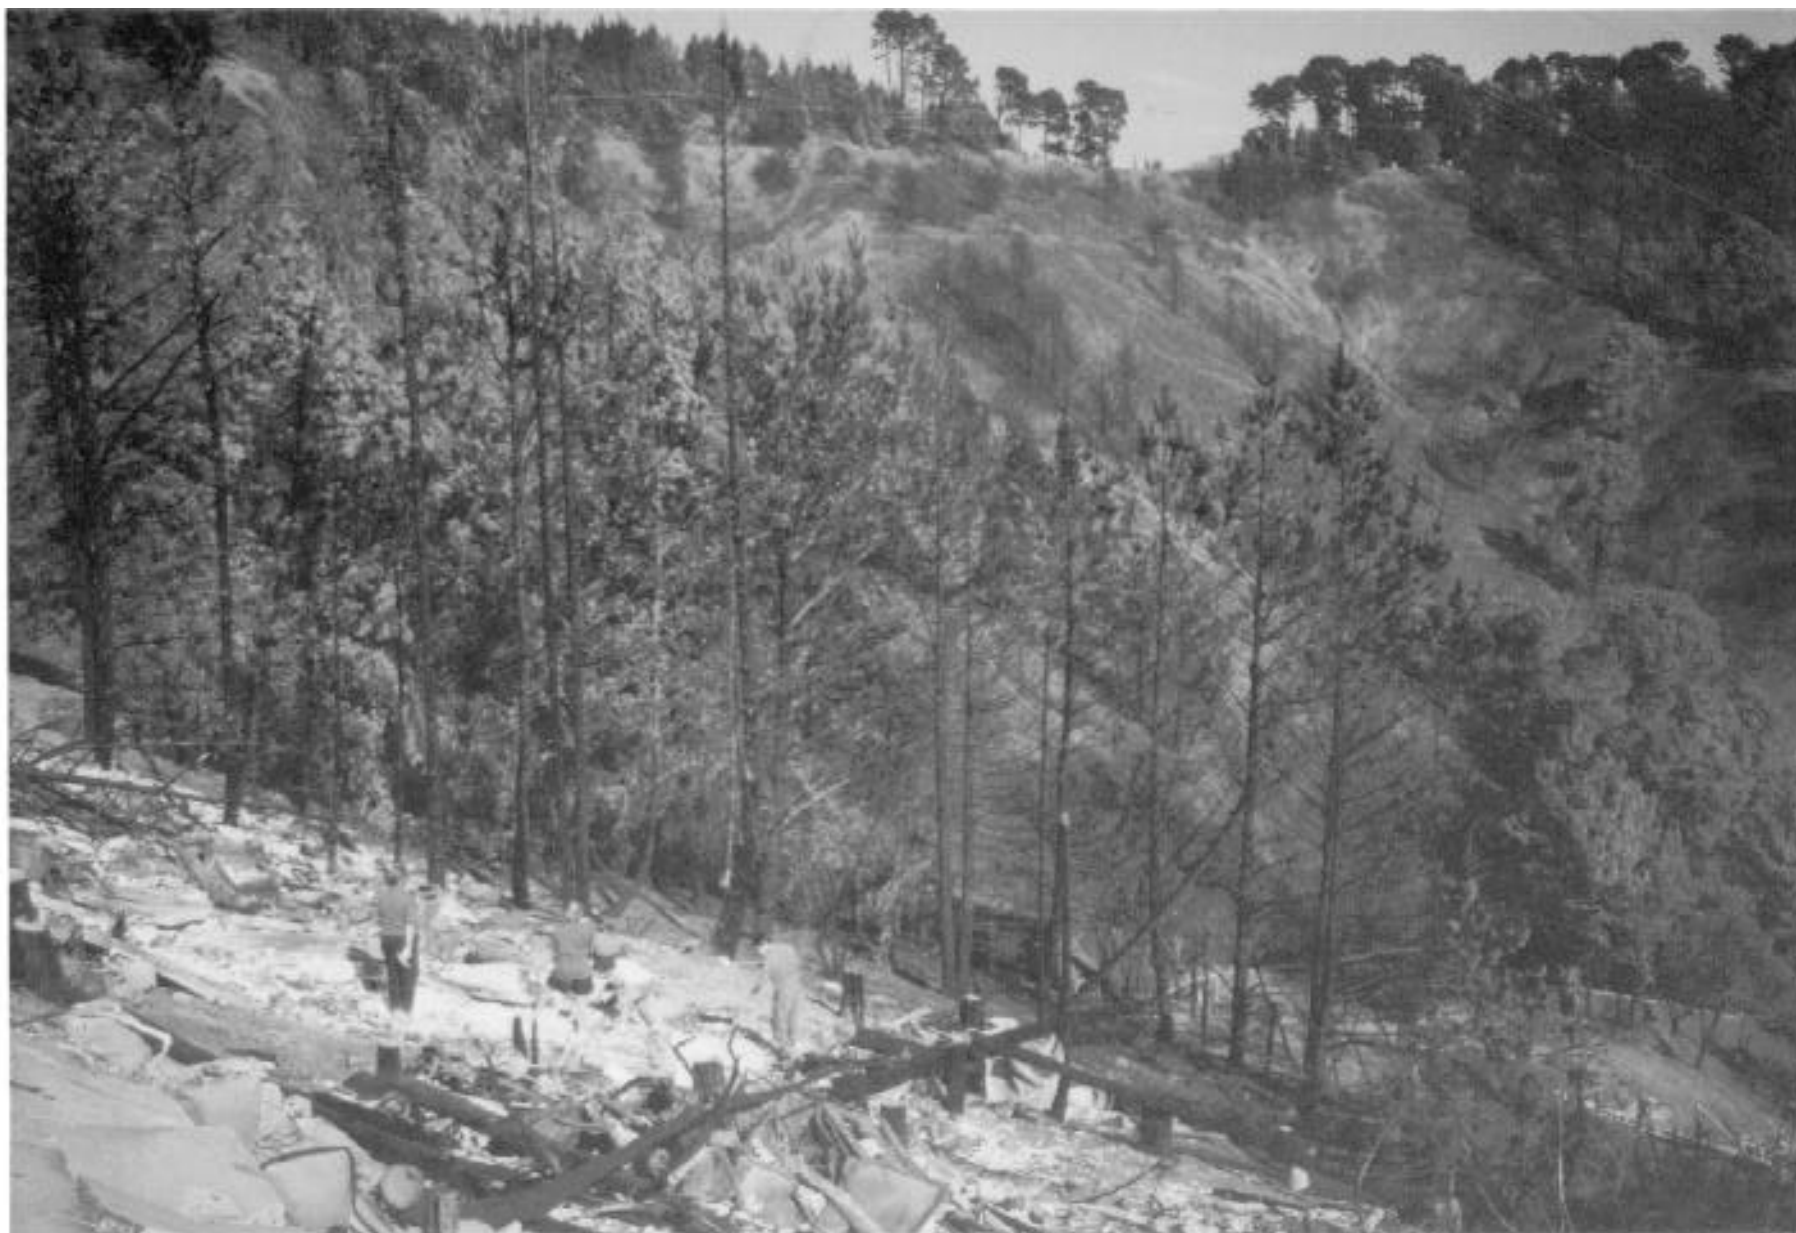
View looking toward the area of fire origin - on the grassy slope in the background. The left flank of the fire spread laterally behind the homes on Buckingham Boulevard and up toward the area in the foreground.

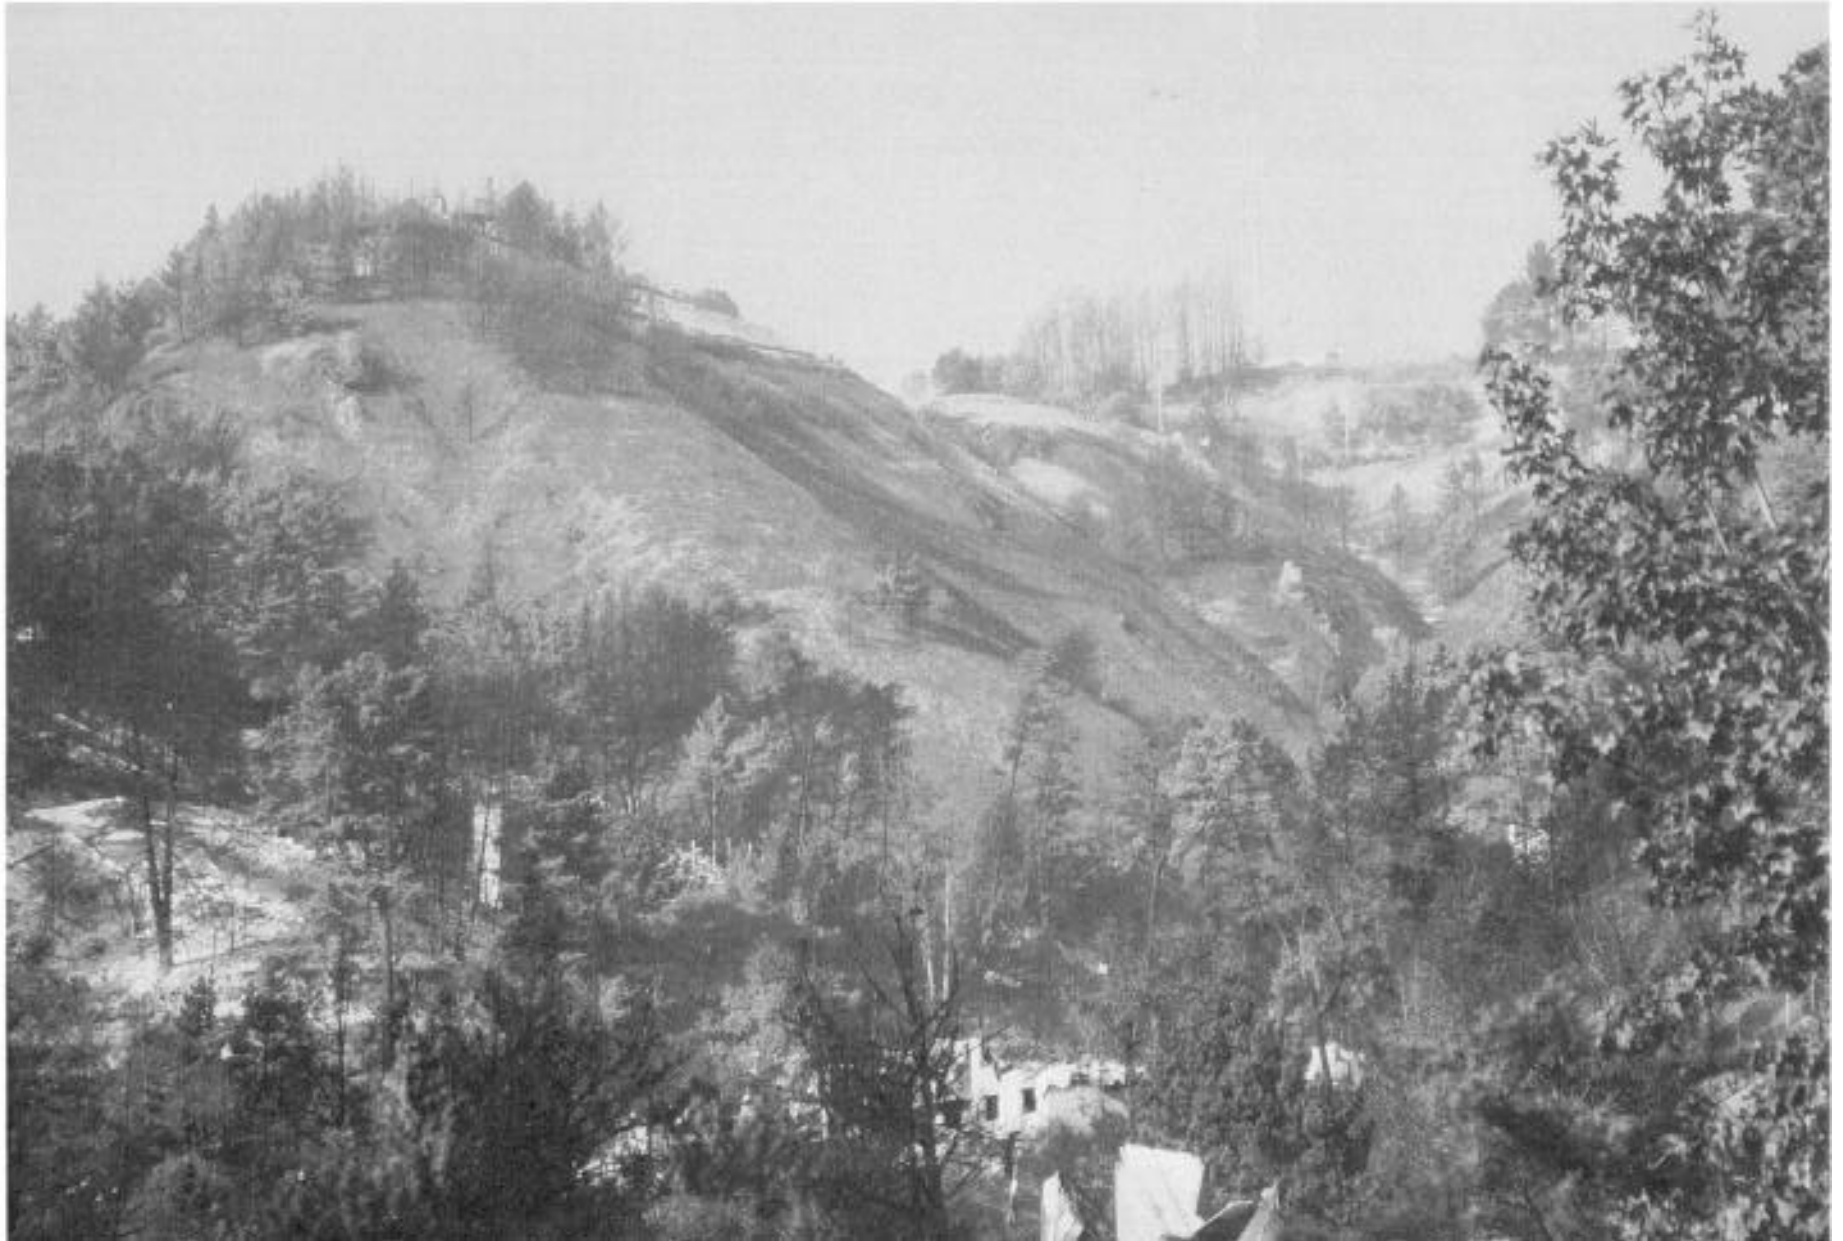
View of the area of fire origin as seen from the Parkwood Apartments. The Saturday fire burned up the grassy slope on the hills toward Marlborough Terrace and the radio tower on Grizzly Peak. The fire on Sunday broke out in the lower part of the original burn area.

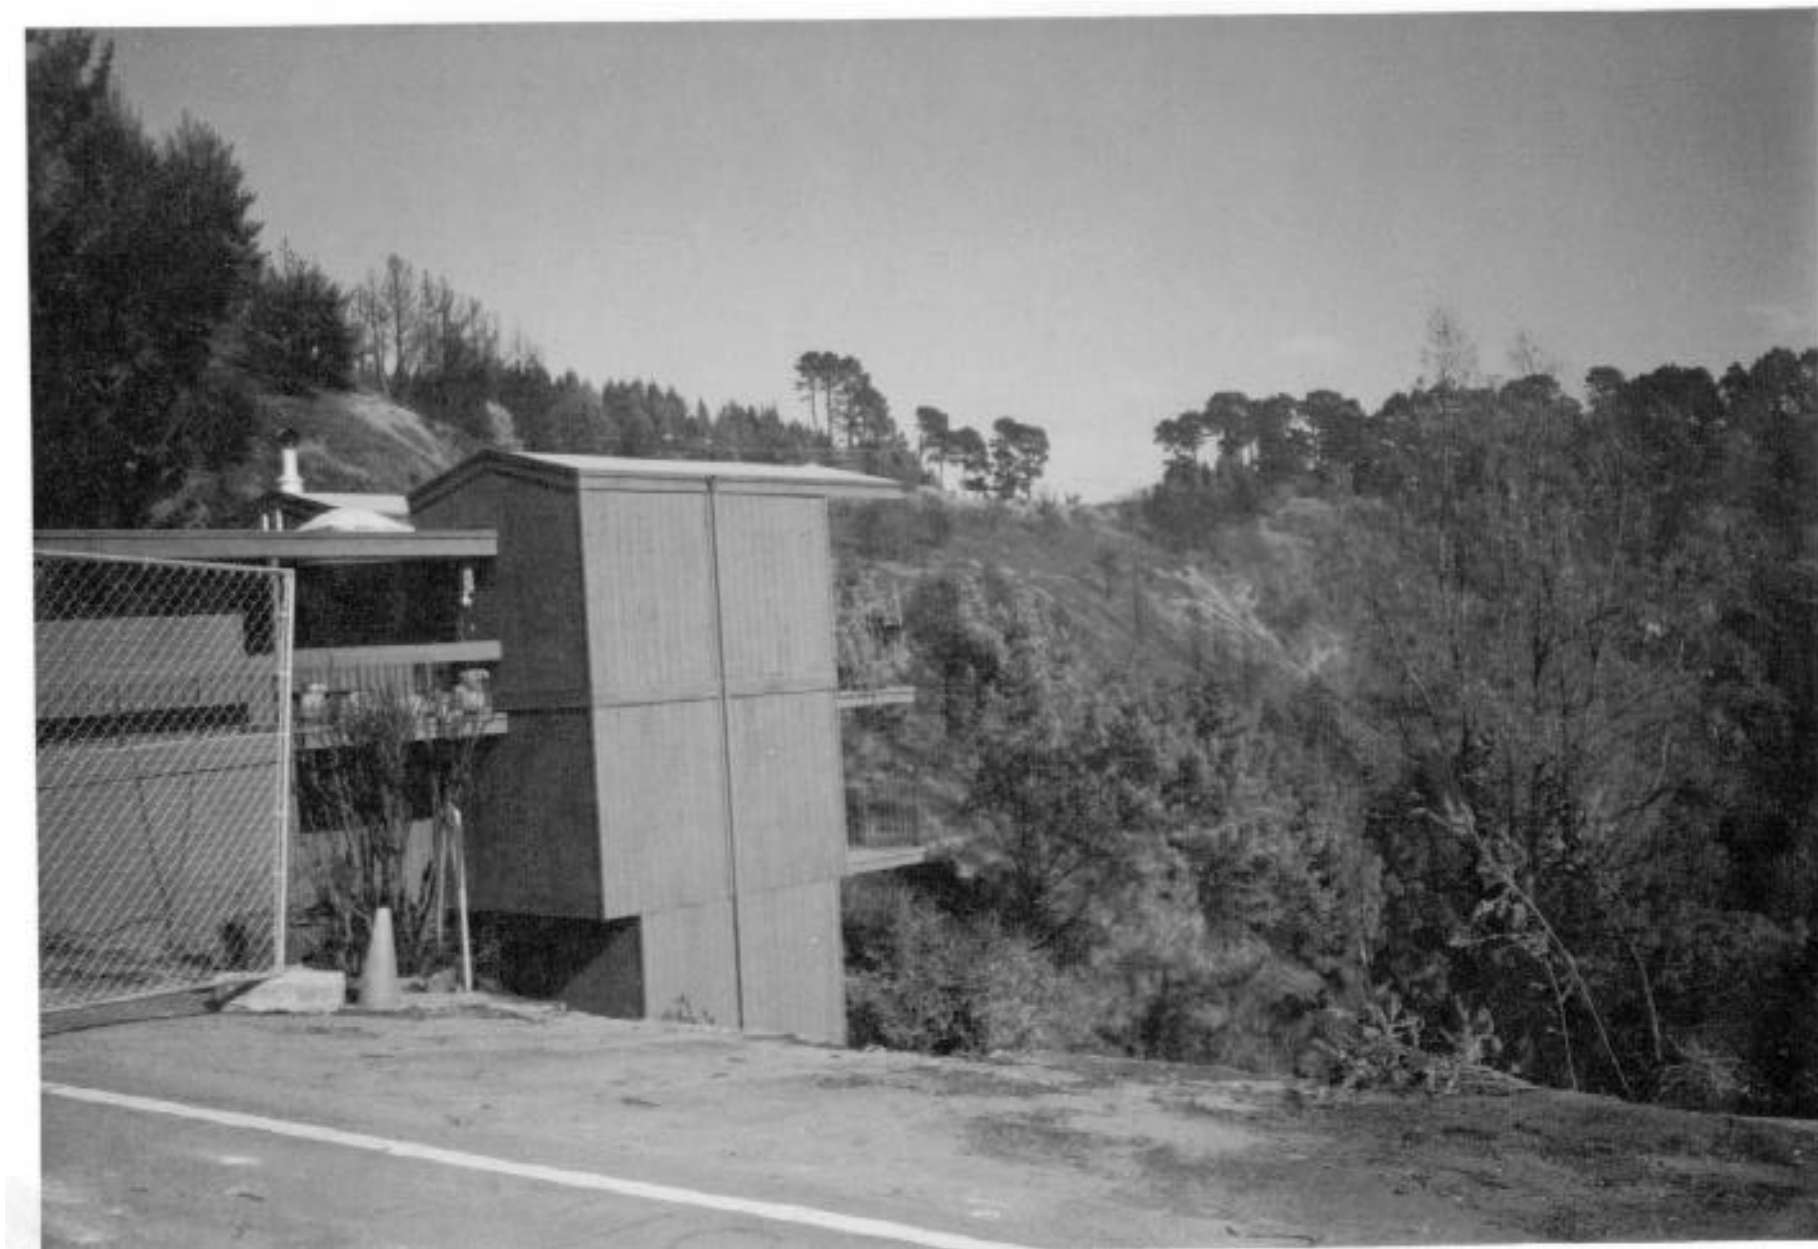
One of the few homes on Marlborough Terrace that was not destroyed by the fire. Houses on both sides burned to the ground.

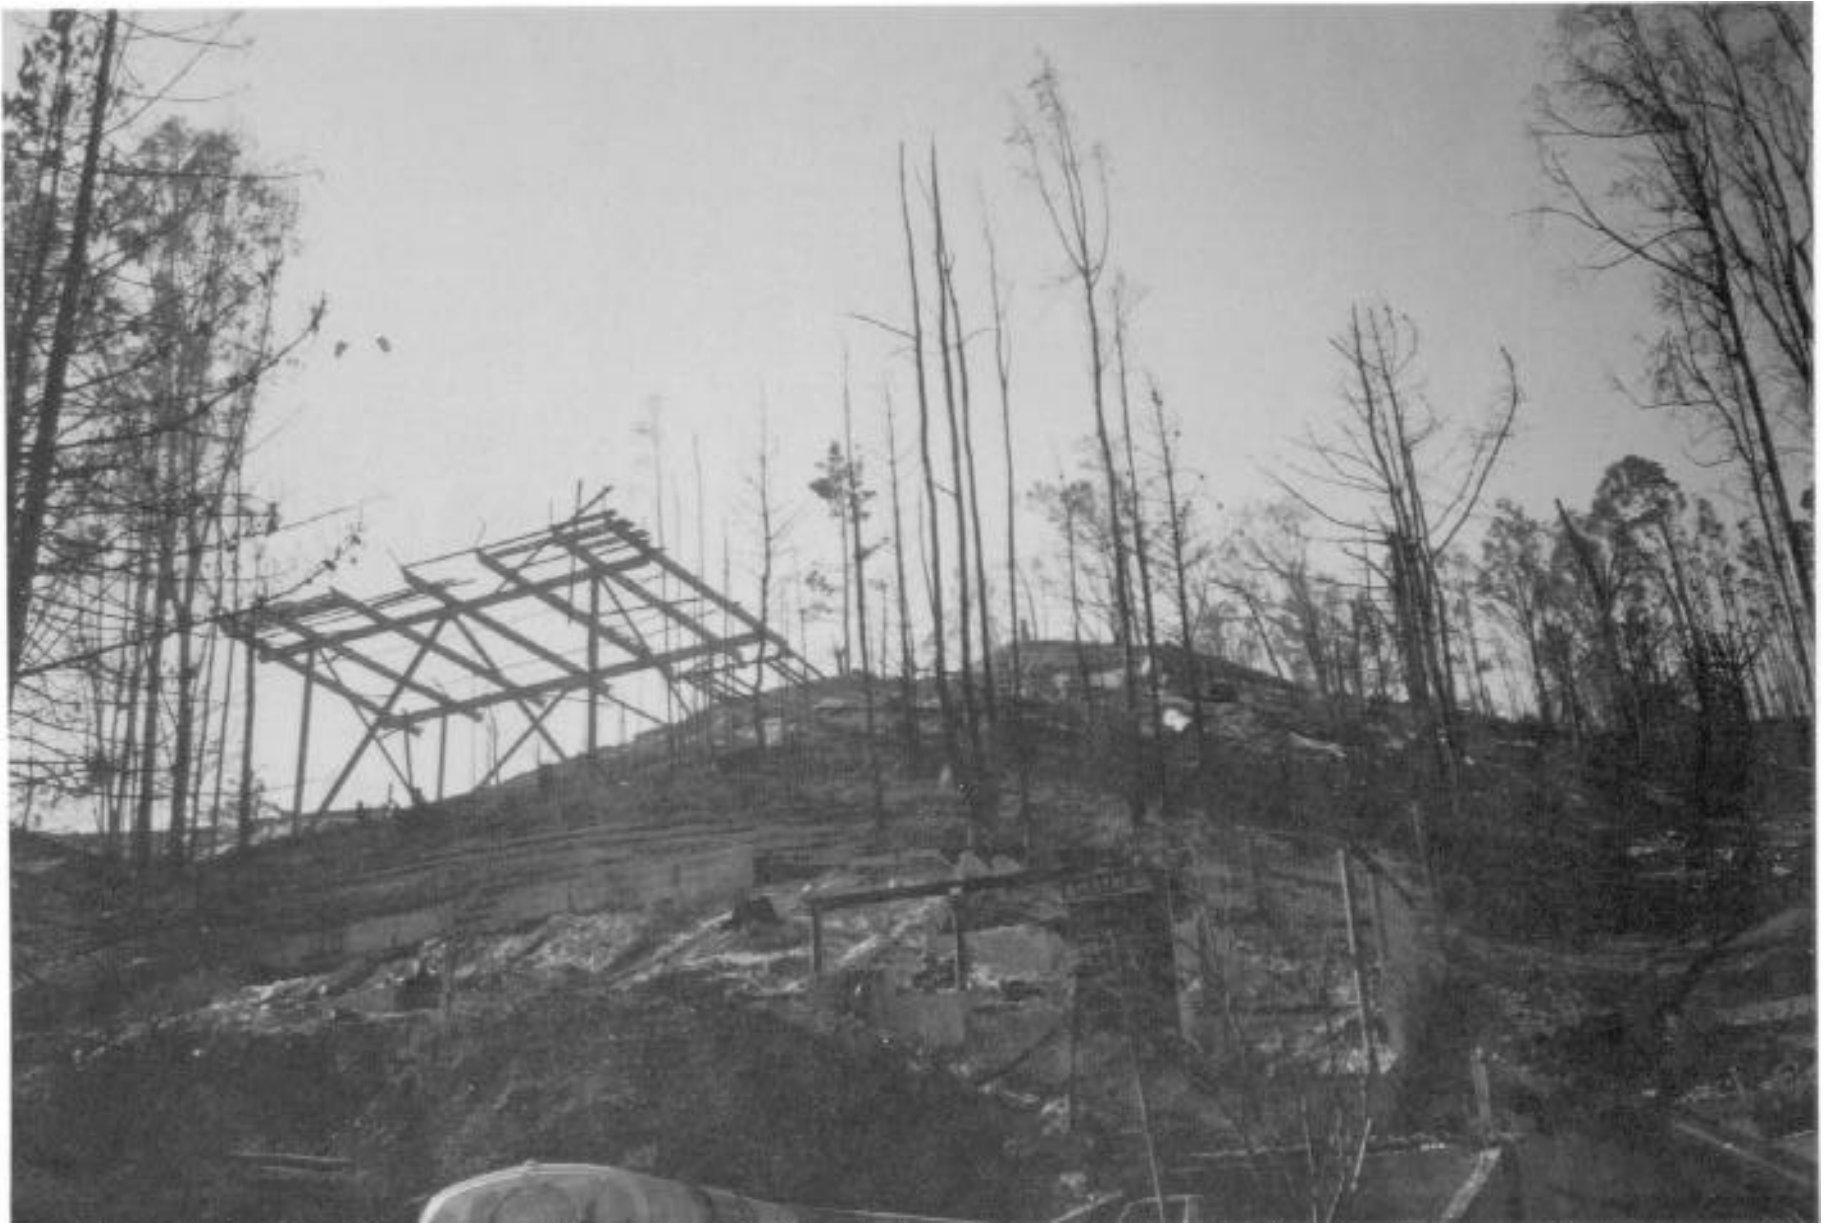
All that remains of one hillside home is the steel supporting structure for the main floor.

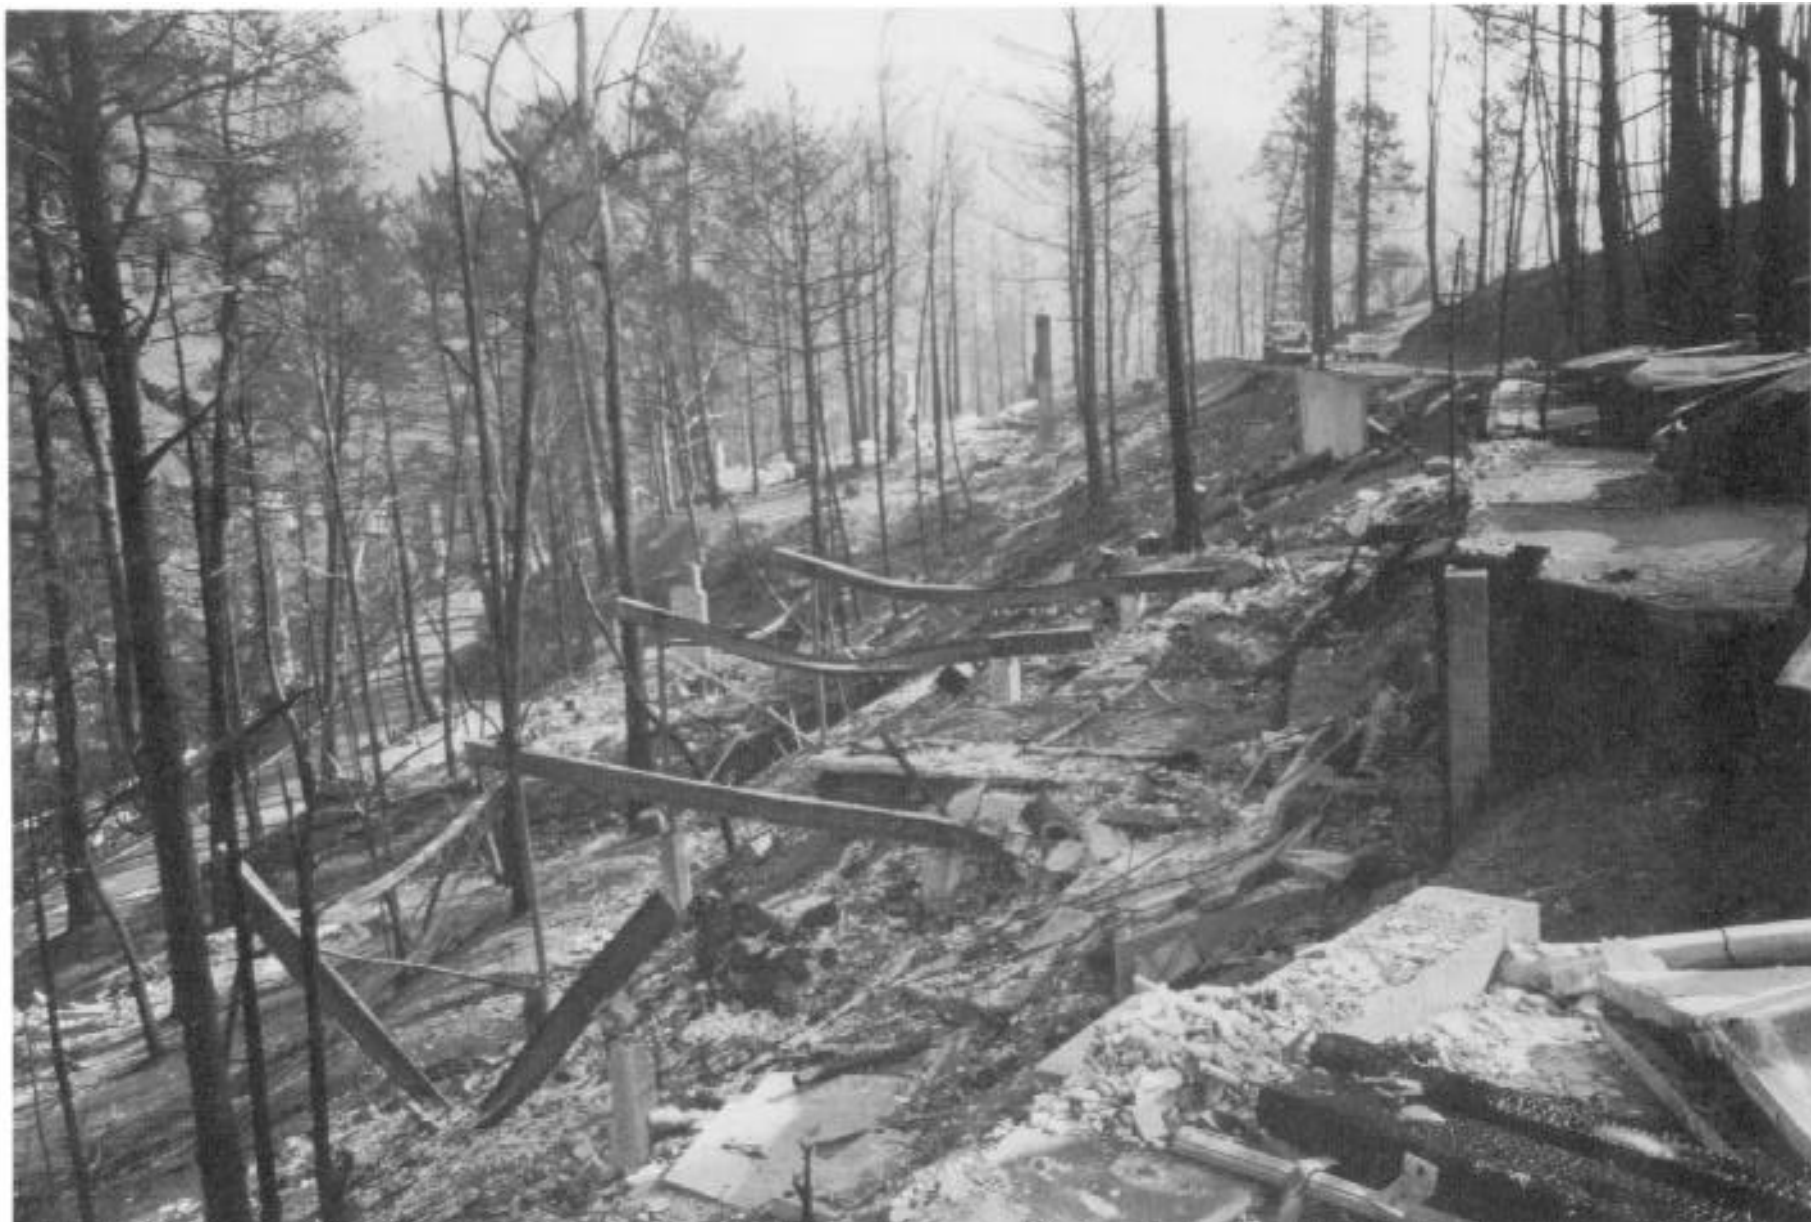
Buckled steel beams mark the location of a destroyed home on Buckingham Boulevard.

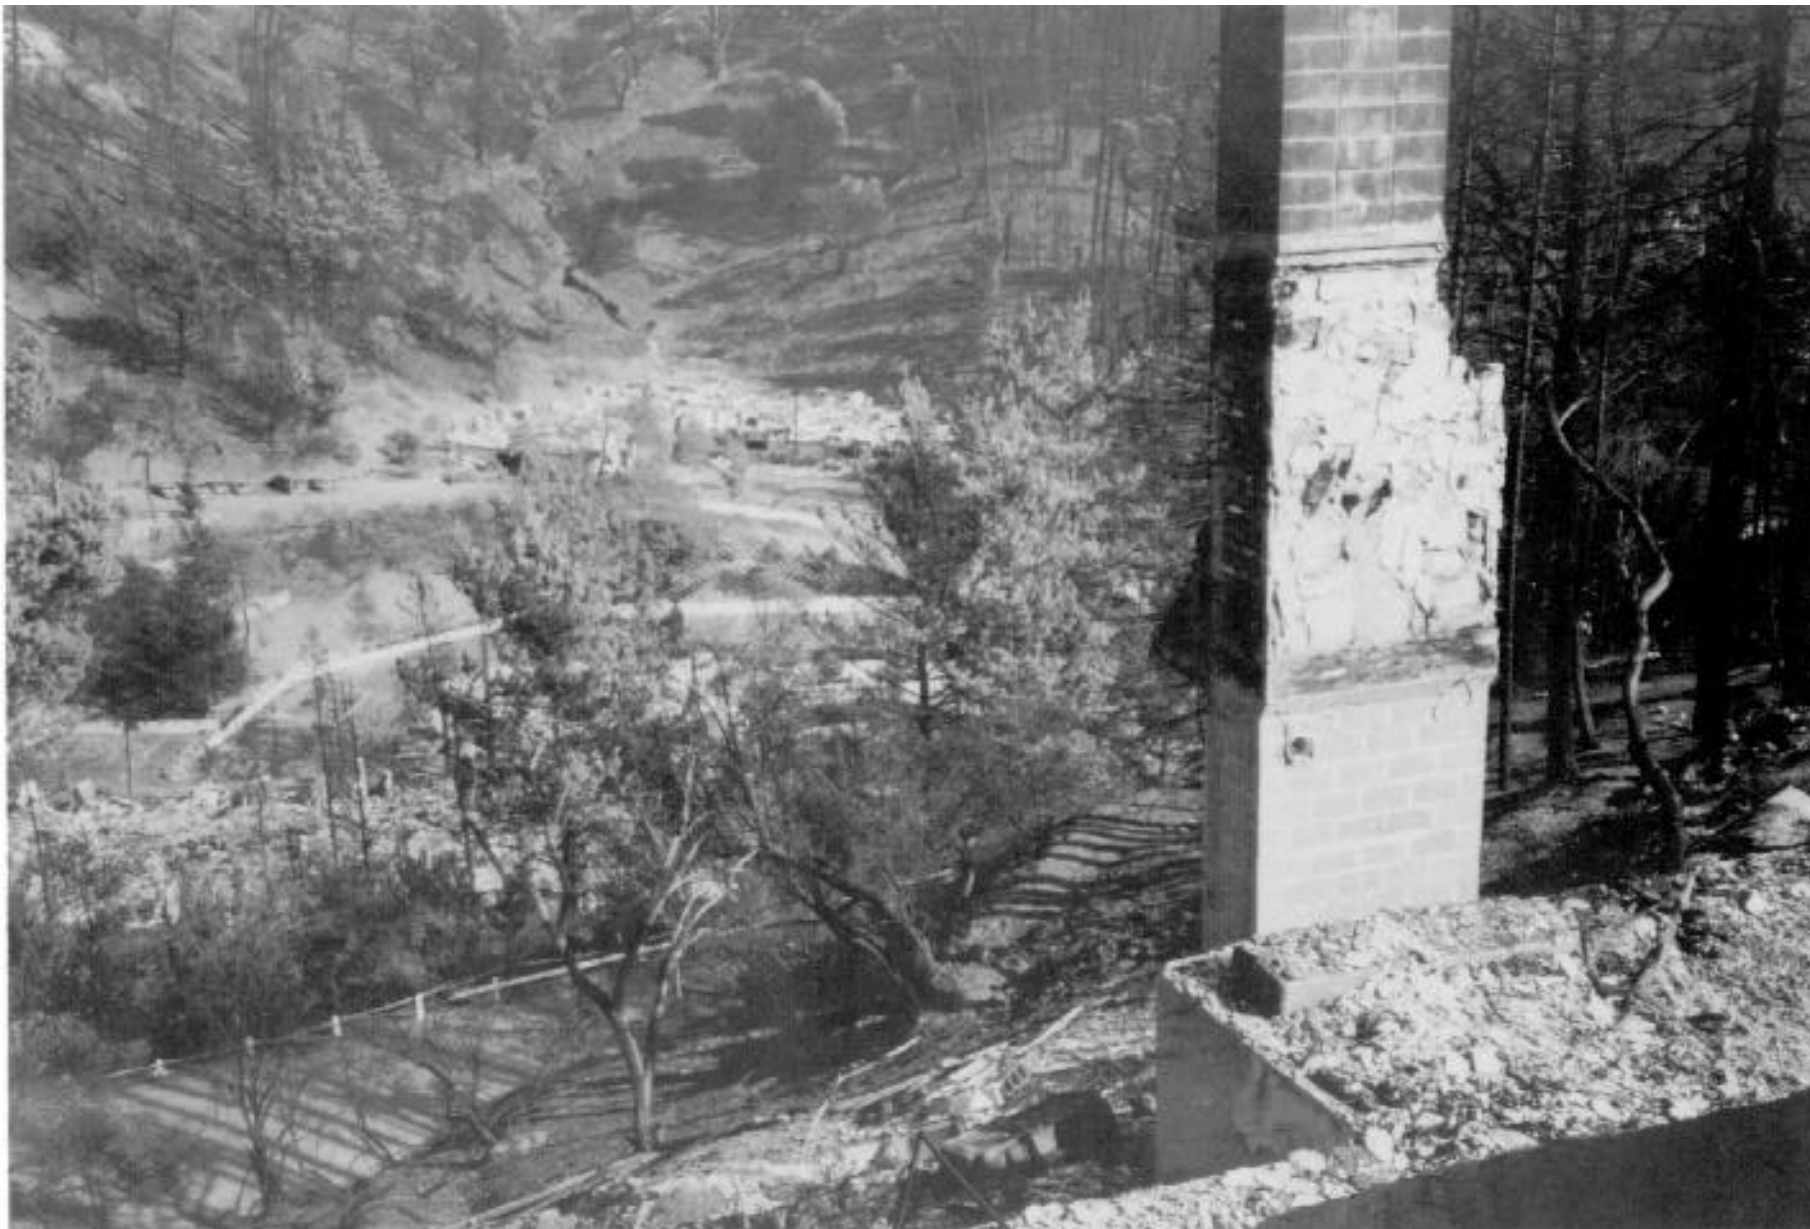
Looking down on the ruins of the Parkwood Apartments from Buckingham Boulevard. Tunnel Road is visible in the lower left corner.

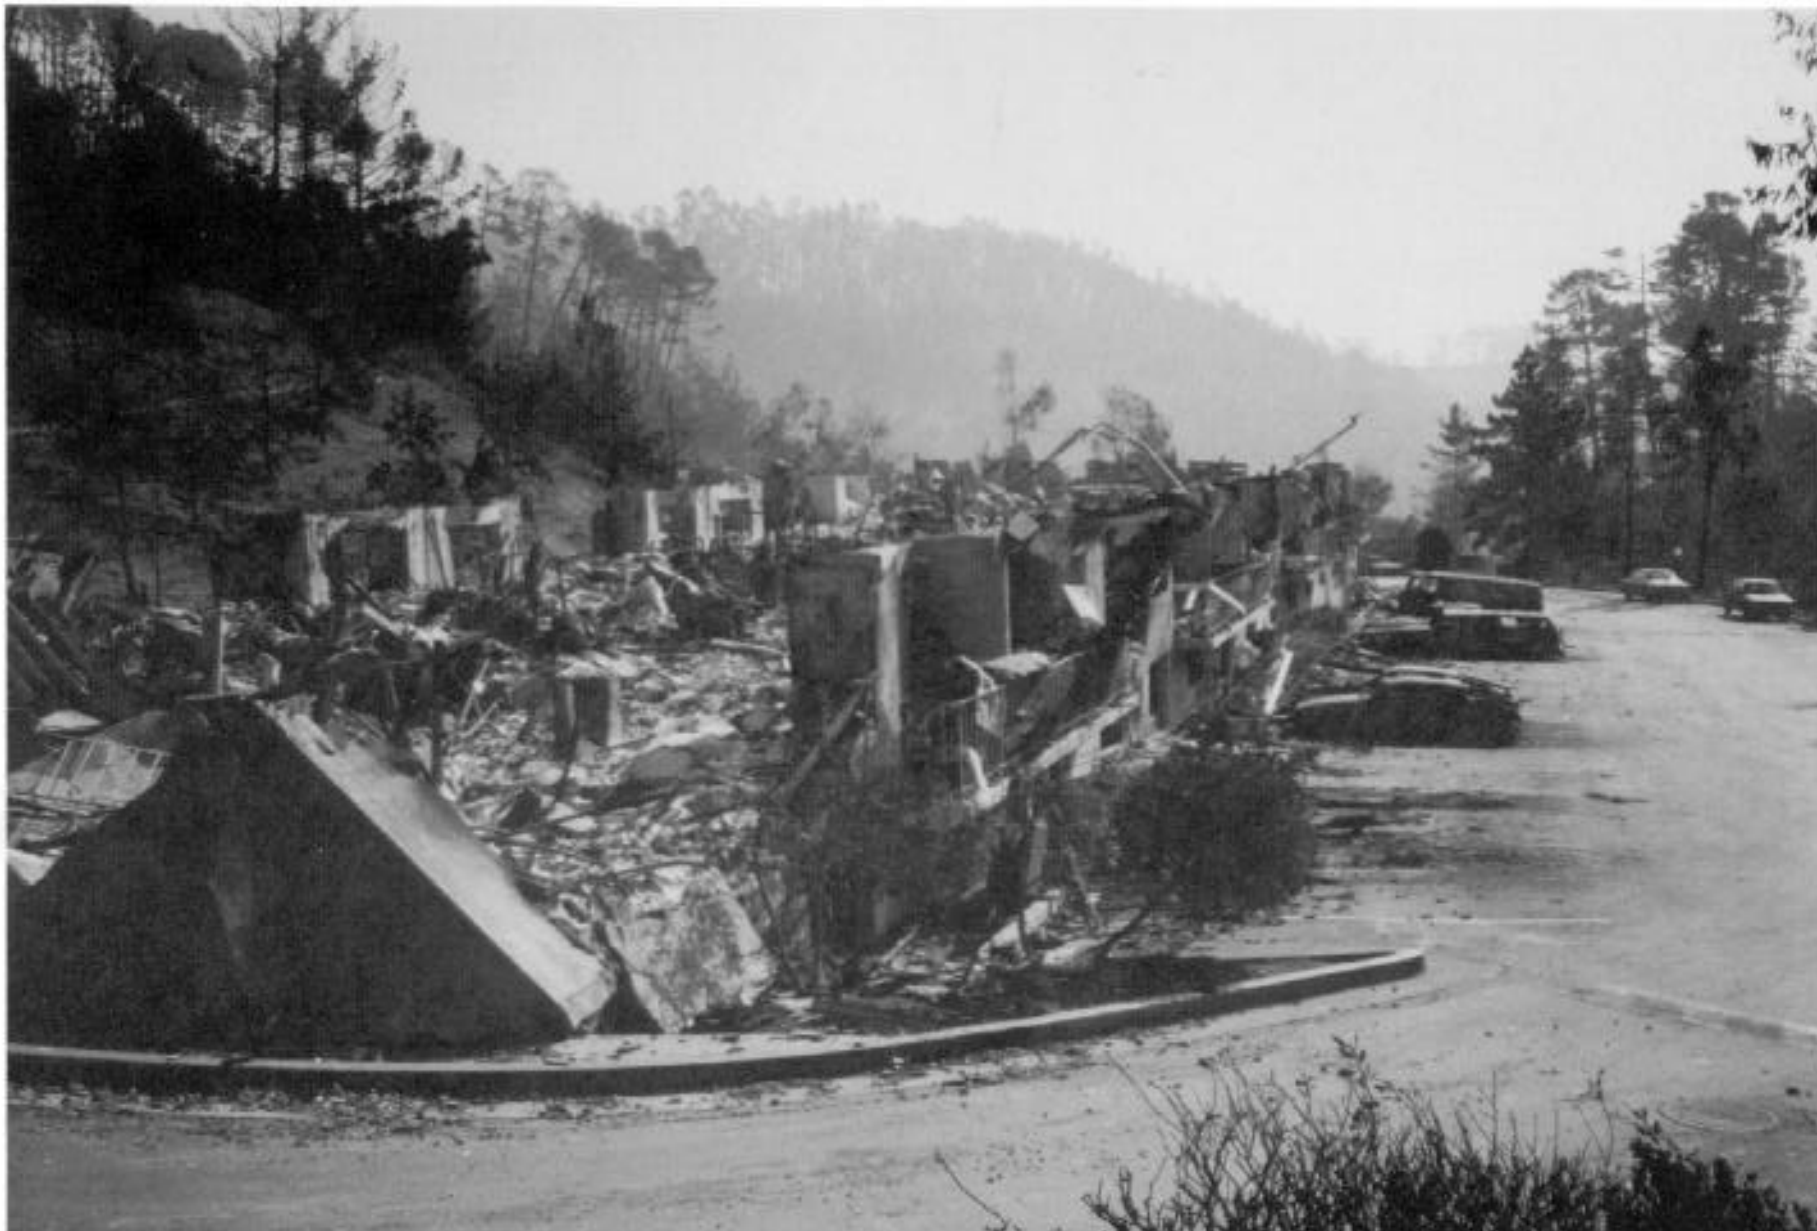
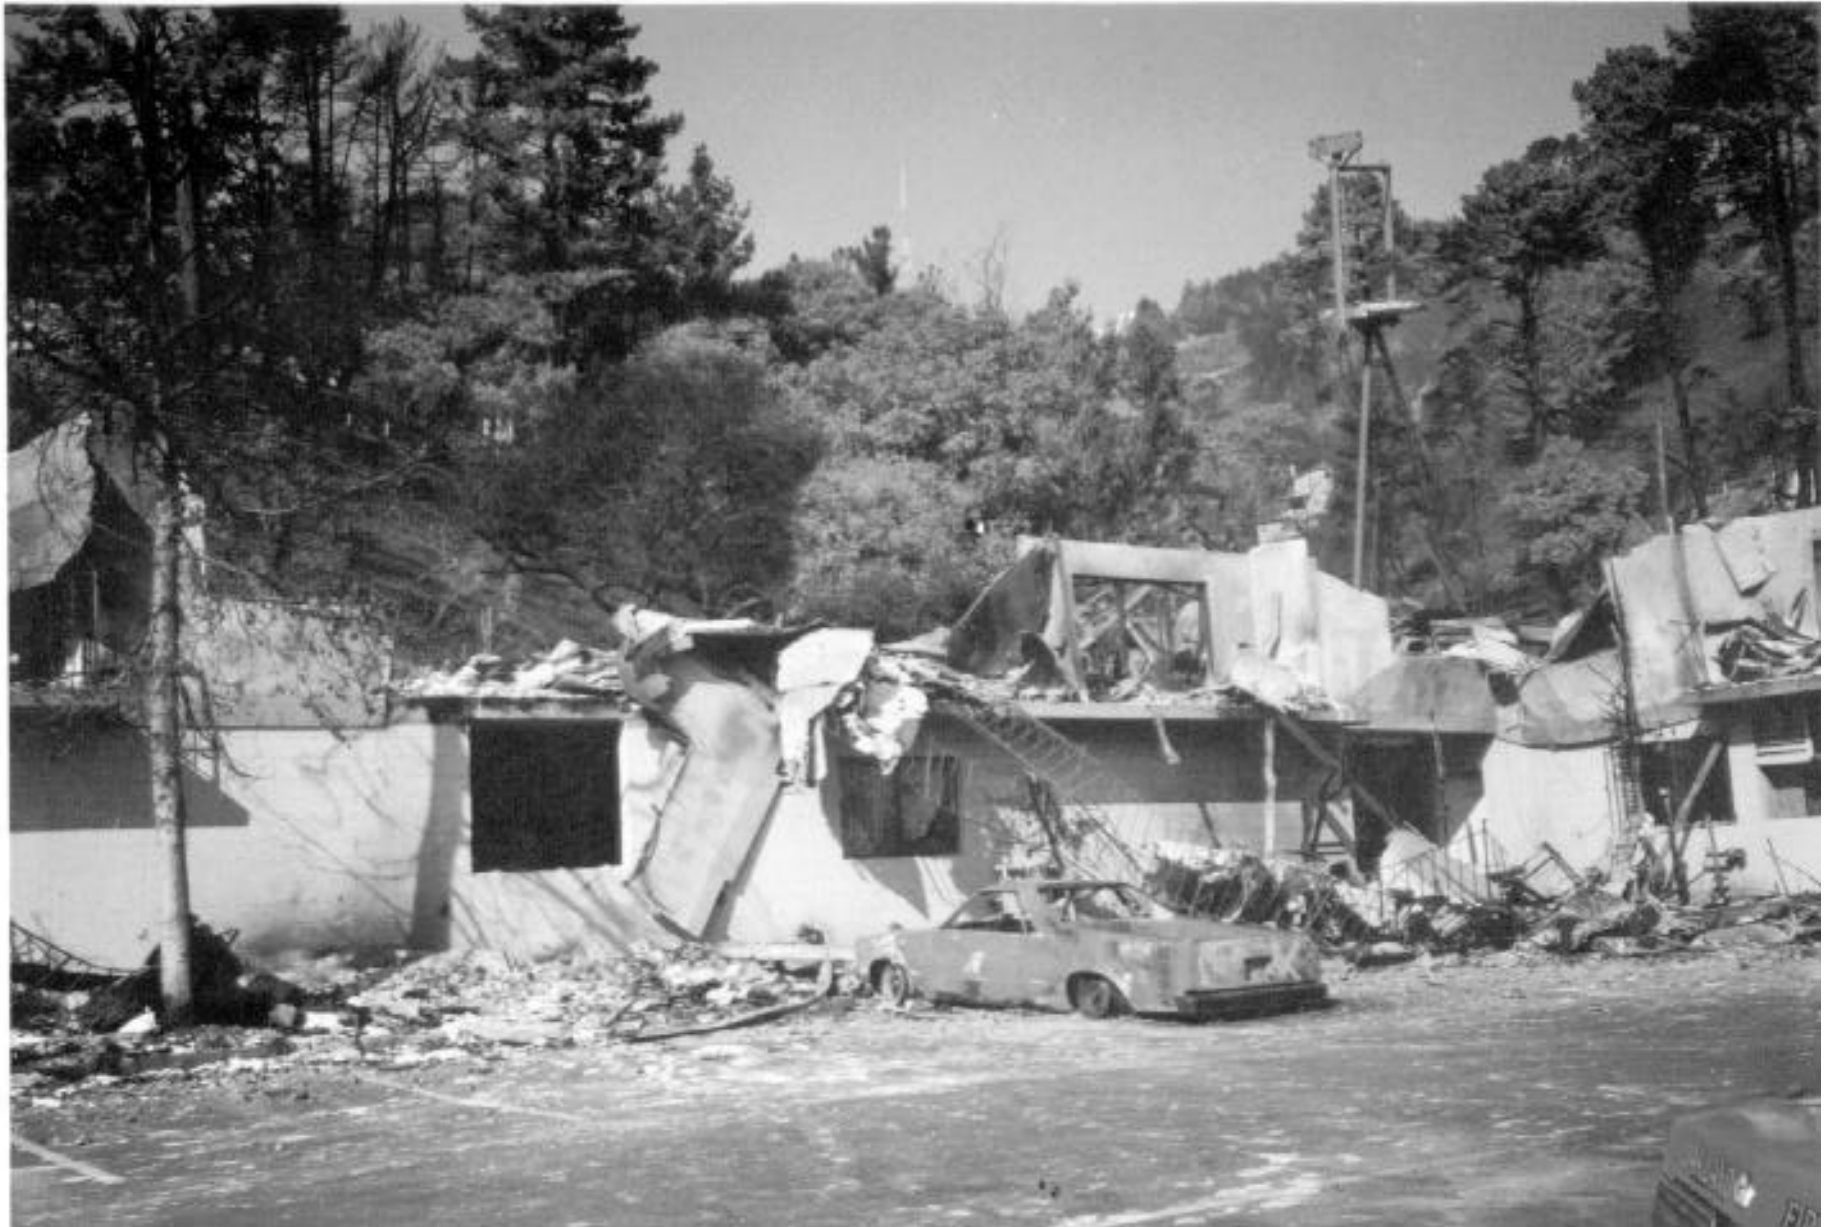
Ruins of the Parkwood Apartments; previously 4-story buildings.
